Indiana DNR Division of Forestry

Forestry Best Management Practices Monitoring Results

**1996 through 2015
Classified Forest & Wildlands BMP Report**

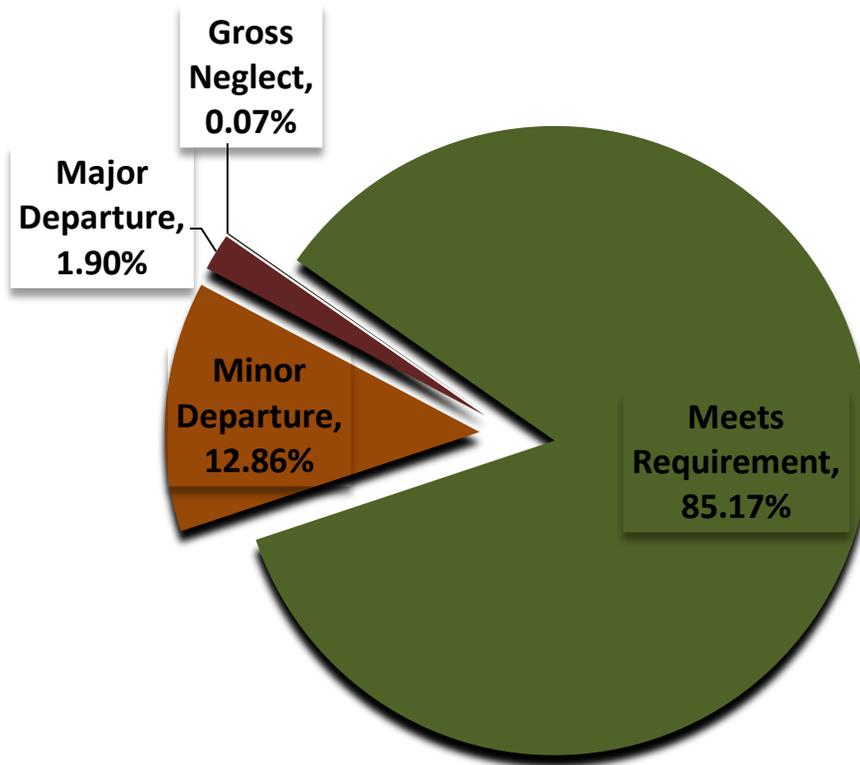
85.17% of the Forestry BMPs were applied as directed in the BMP guidelines, 12.86% had minor departures as defined in the monitoring sheet (Appendix). There have been 288 major departures, and they add up to 1.90% of all practices monitored. Of the total 400 sites monitored on CFW, 10 practices have scored “Total Negligence” for 0.07%, Figure 1.

Figure 1: Overall CFW BMP application percentages.

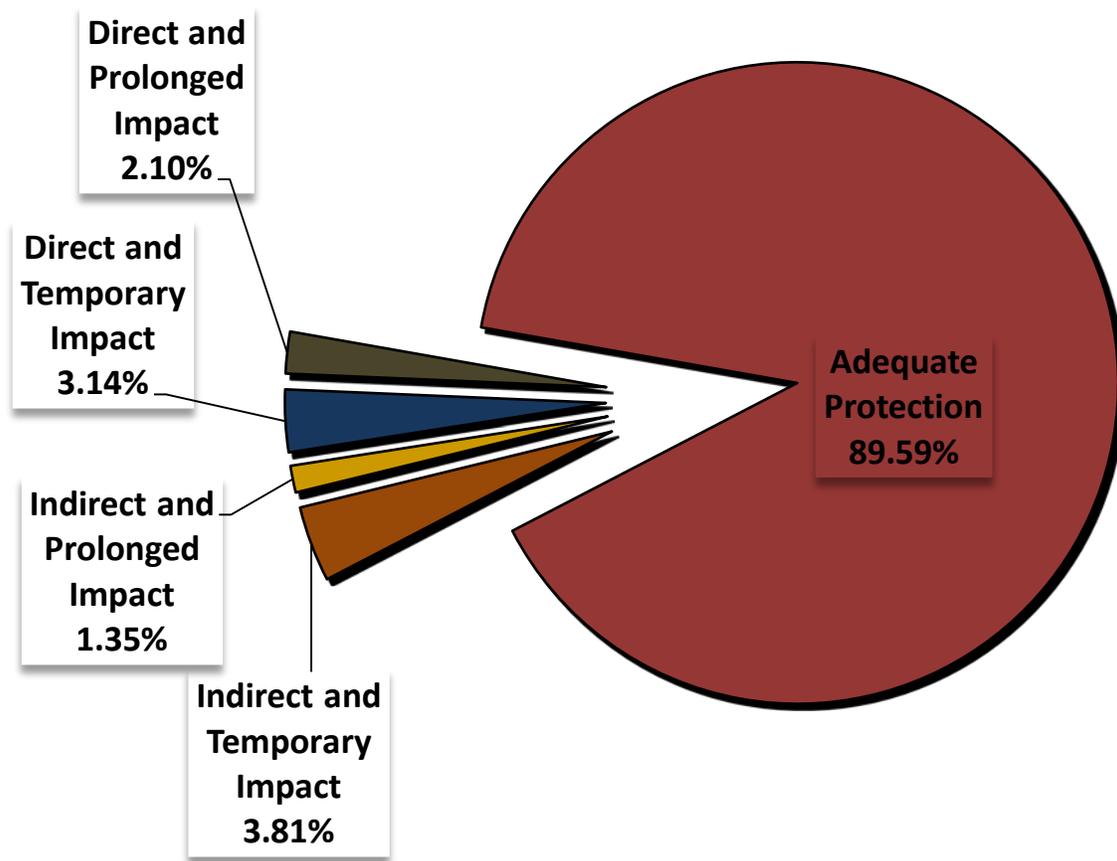
Effectiveness rates are used to evaluate the success of the forestry BMPs applied to a site. The CFW effectiveness rate for the 400 sites monitored is 89.59%. Indirect and temporary impacts to water quality were found 3.81% of the time, indirect and prolonged impacts were found to occur 1.35% of the time, 3.14% of the time direct and temporary impacts occurred and there were 2.10% direct and prolonged impacts to water quality, Figure 2.

Figure 2: Overall CFW BMP effectiveness percentages.

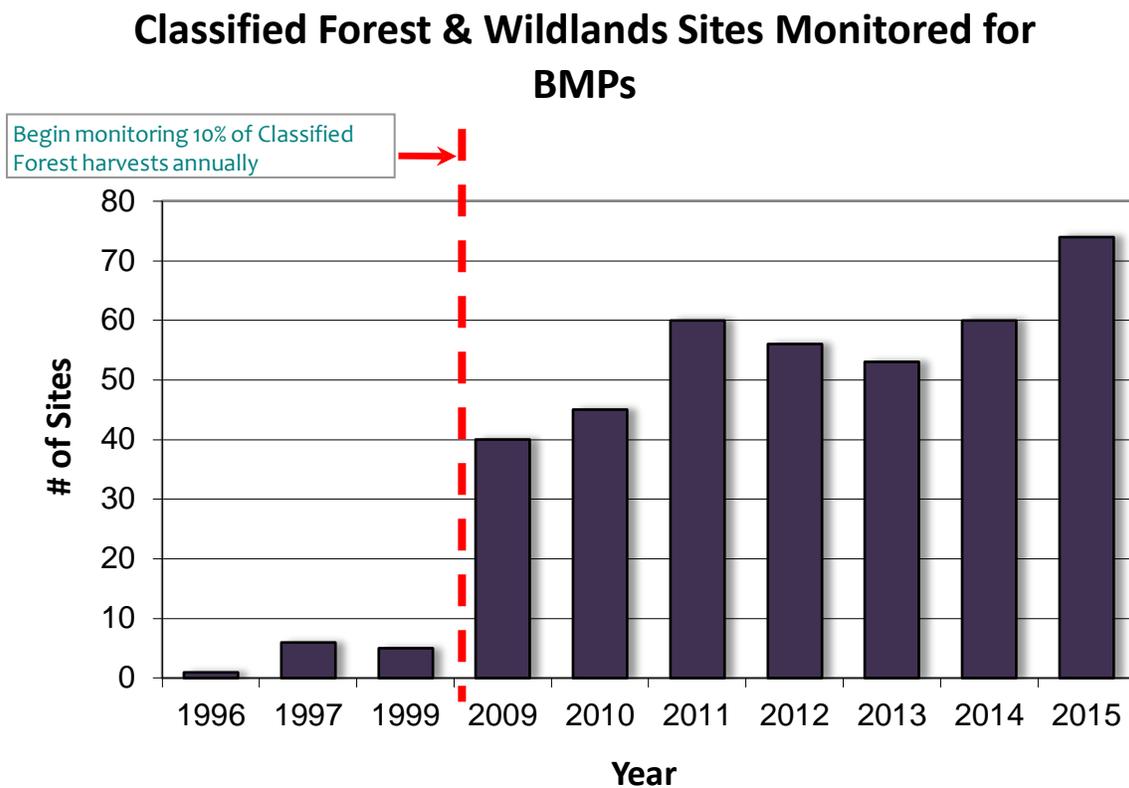
Figure 3: 1 CFW site was monitored in 1996, 6 in 1997, 5 in 1999, 40 in 2009, 45 in 2010, 60 in 2011, 56 in 2012, 53 in 2013, 60 in 2014 and 74 in 2015.

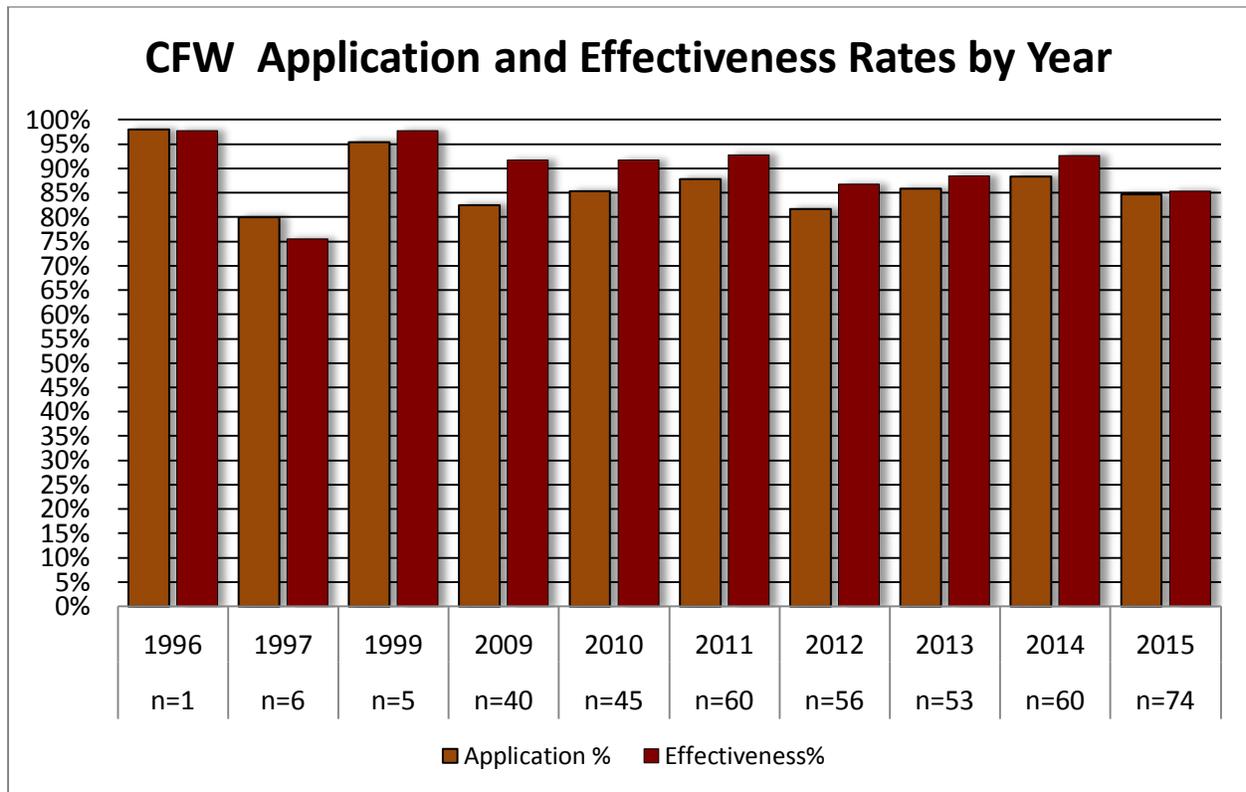
Breaking down data by years can be a useful way to interpret it. CFW sites have only been monitored on a consistent basis since 2009, therefore it is difficult to draw any conclusions about yearly trends yet. However, continuing to examine the data in this way will be useful for the Division of Forestry to determine if any interventions or further education is needed to continue a high level of BMP implementation and success on CFW grounds.

Figure 4. Application and effectiveness scores by year of all CFW sites.
